Consumer Product Service
Manager of Tehnical Support
TECH TIP

MODEL: ATARI CX5200

MODEL: CX5200

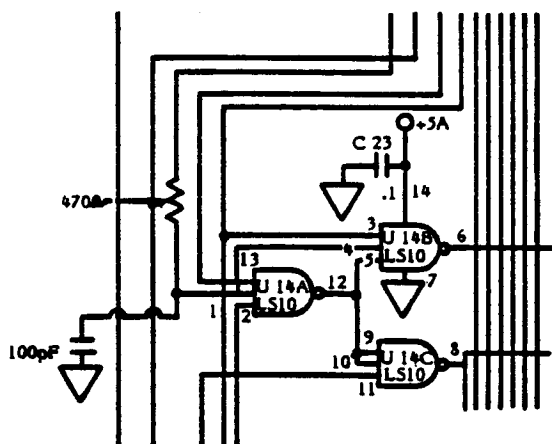
Figure 1. CX5200 Schematic (R-C Network)

Rockwell MPUs with date code of 8250 and later (stamped with the letters RC) have a timing defect.

A factory modification adds an R-C network on the component side of the CX5200 PC Board at IC U14A (pin 1) and U6A (pin 4) (see Figures 1 and 2).

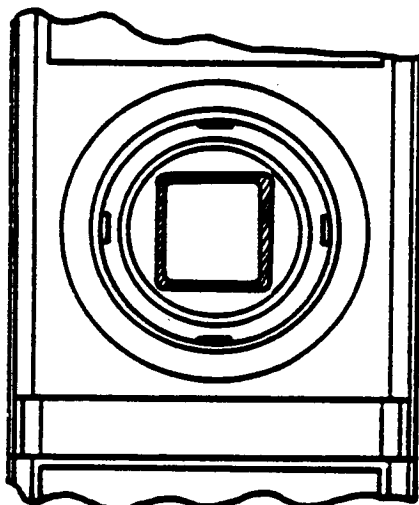
A

Old Top Controller Case

- 1) Follow Disassembly instructions for the CX5200 Controller in the CX5200 Field Service Manual.
- 2) Remove the top controller case and pull off the joystick handle.
- 3) Remove the boot retaining ring. Remove and discard the damaged boot.
- 4) If the top controller case contains the square ridge around the access well, as illustrated in "A" below, remove and discard it. Replace it with the new top controller case in which this square ridge has been removed, as illustrated in "B".

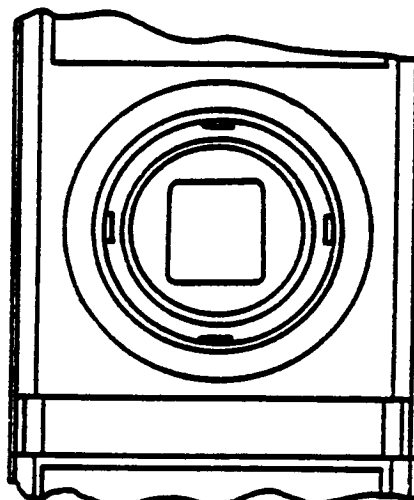
B

New Top Controller Case

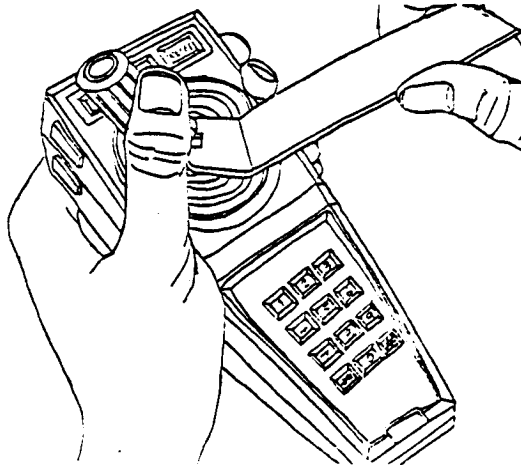
Figure 1. Controller Knob Removal.

It has been learned that removal of the 5200 Controller Knob is difficult.

Push the knob shaft into one of the corners of the top housing opening. Push down the boot with the tool to expose the shaft. Push the tool toward the shaft until the shaft is inside the notch of the tool's head (See Figure 1). Now, gently lever the tool, and the knob will pop off.

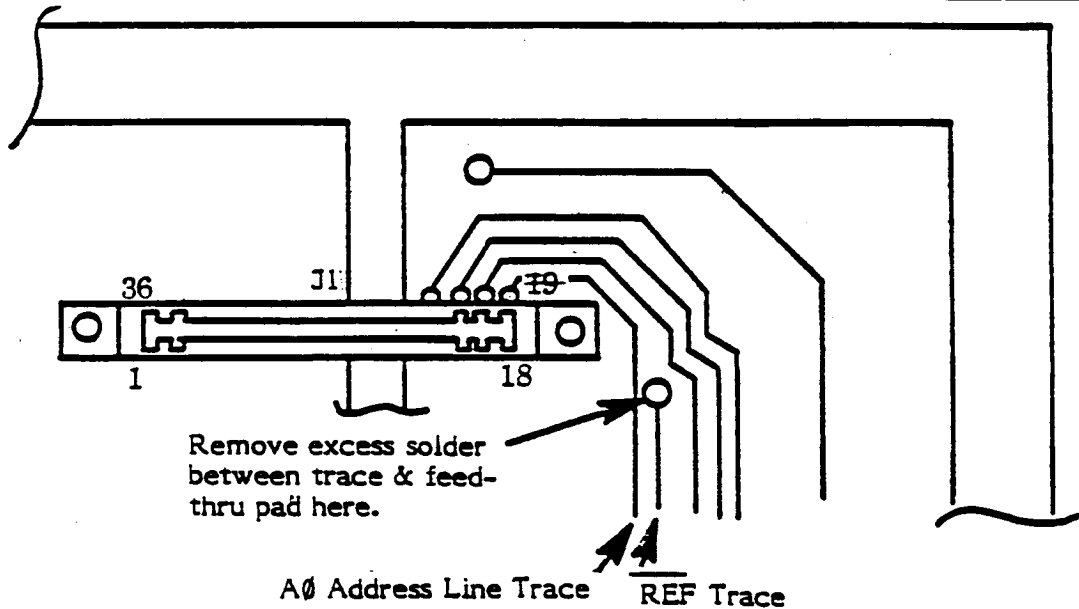
Figure 1. 5200 PCB Solder Side at J1

Some 5200 units display a blank dark screen or a screen with garbled information. The probable cause for either of these symptoms is an intermittent solder short (bridge) on the PCB between the A0 Address line trace and the feedthru pad of the REF Line trace (near connector J1).

- 1) Turn off power, and disconnect AC and interconnect cables.
- 2) Disassemble unit to expose the component side of the PCB (CA018087).
- 3) Locate connector J1, the adjacent A0 Address trace and the feed-thru pad of the REF Trace (See Figure 1).
- 4) Carefully remove the excess solder from the pad and wipe the area clean. Inspect the pad and if necessary use an X-acto knife to cut a shallow groove between the A0 Address Line and the feedthru pad. Be very carefully not to nick or cut the trace adjacent to the pad.
- 5) Reassemble and test the unit.

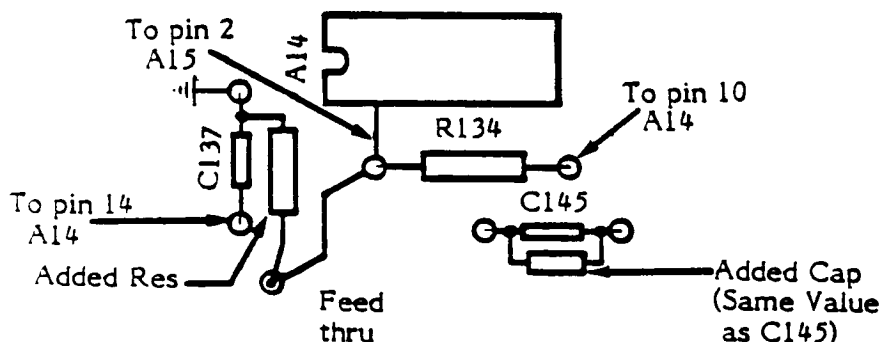
Figure 1. Resistor/Capacitor Fix

The timing of some Signetics I.C.'s causes RAM information to be distorted. This results in a scrambled screen display or worse - no video at all.

C145 (C014179-24) should be paralleled with another 390pf capacitor (C014179-24) and a 470 Ohm resistor (14-5471) be added from C137 to R134 (See Figure 1).

If the unit still displays a faulty screen, swapout A16 and A17 with another vendor's component. DO NOT USE A SIGNETICS I.C.

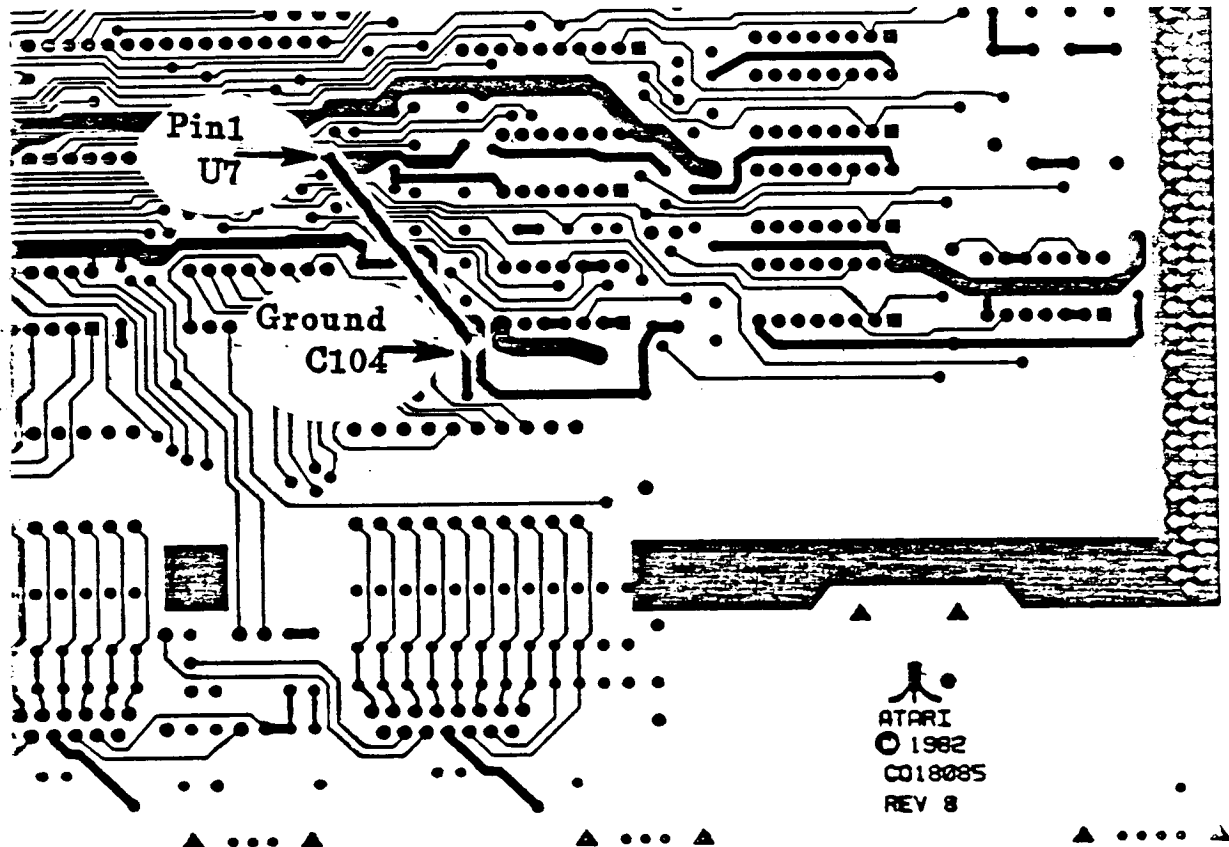
Figure 1. Sleeve Buss Wire Placement

Some 5200 PCB's demonstrate paddle jitter caused by a ripple on the +5v power supply to the POKEY IC (U7), and an inadequate ground trace at Pin 1 of U7.

To eliminate paddle jitter a 10uf capacitor (C017516) must be soldered directly across the +5v and ground legs (Pins 1 and 17) of U7. A sleeved jumper wire must also be connected between Pin 1 of U7 and another ground trace.

- 1) Trim Capacitor to an overall length of 1 5/8 - 1 3/4 inches.
- 2) Cover the capacitor leads with sleeving. Approximately 1/8 inch of the lead must extend beyond the sleeving for soldering.
- 3) Solder the "+" lead of the cap to Pin 17 of U7 (+5 volts). Solder to the I.C. Leg
- 4) Solder other cap lead to Pin 1 of U7 (ground). Solder to the I.C. Leg.
- 5) Cover 1 1/4 inches of buss wire with plastic sleeving leaving sufficient length at each end for soldering.
- 6) On the solder side of the PCB solder one end of the sleeved buss wire to Pin 1 of U7. See Figure 1.
- 7) Solder the other end of the sleeved wire to the ground lead of C104. See Figure 1.

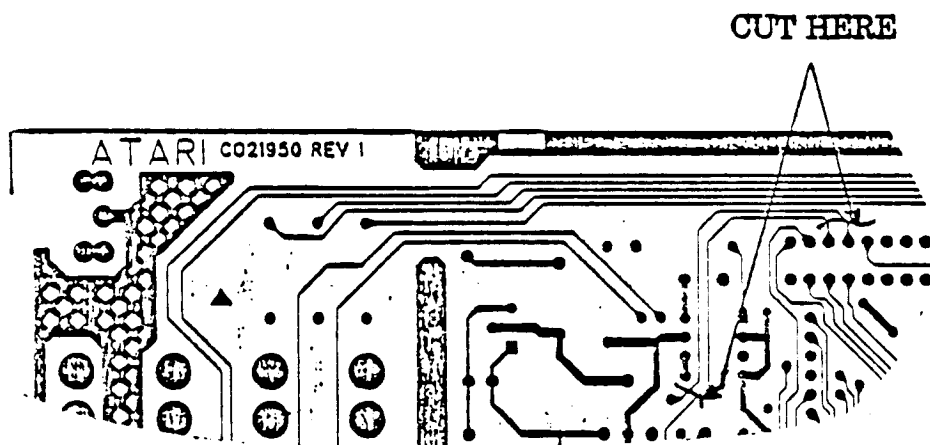
Figure 1. Trace Cuts

Screen jitters when Ms. Pacman is played.

On the solder side of the PCB, use two jumper wires to reroute traces between J1, Pins 15 and 16 and the data bus (See MODIFICATION PROCEDURES).

1. On the solder side of the Adaptor PCB, carefully cut the traces shown in Figure 1.

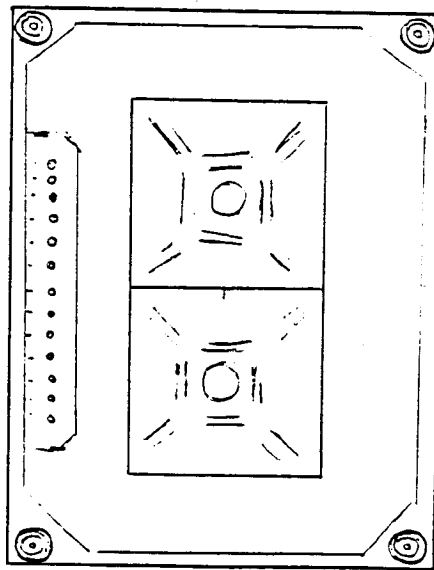
Figure 1. Spacer Installation

The backing of the telephone-style keypads used on the 5200 Retail Demonstrator have been breaking because of insufficient support.

- 1) Remove the four nuts and washers that hold the keyboard plate to the control panel.
- 2) Remove the keyboard plate.
- 3) Install spacers (see Figure 1).

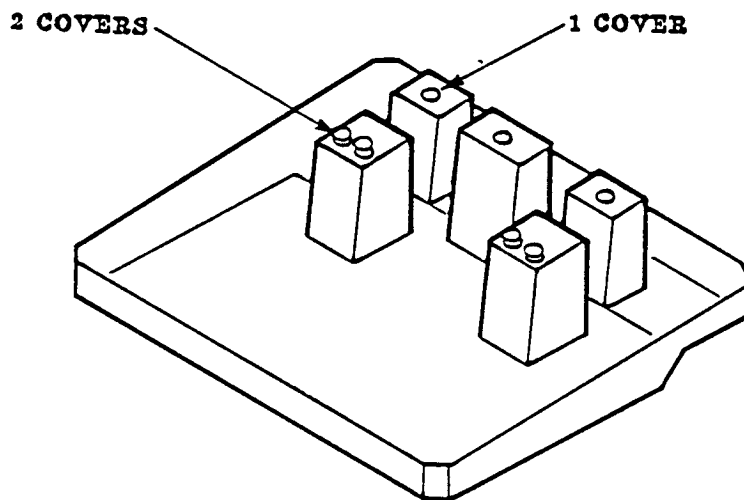
Figure 1. Hole Cover Placement

- 1) The metal domes under the fire buttons shift around under the mylar sheeting causing sporadic contact.
- 2) The 12-button keypad or the SELECT keypad slips under the top case.

Use eleven ATARI 810TM Disk Drive hole covers (C014106) and place them in the positions on the bottom case shown in Figure 1.
